89 Courtenay Place

Building Services Feasibility Study

IZ000-FEASIBILITY-BLDGSERV-RPT-001 | A1

15th July 2016

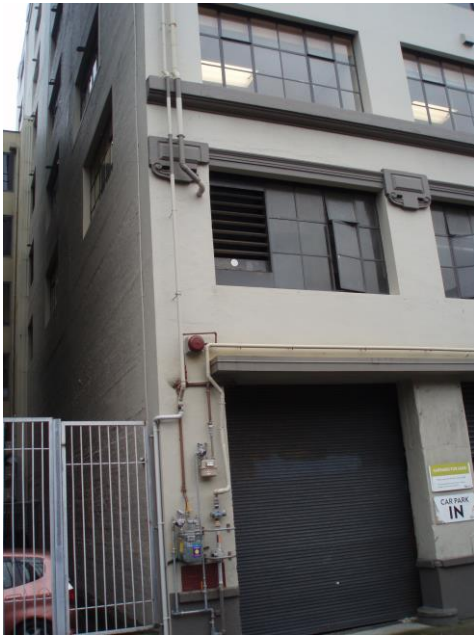
Existing Gas Meters

- The gas meter and regulator for the new supply should be located within a ventilated gas metre room accessible from York St along with a purpose vertical riser to the roof plant room.

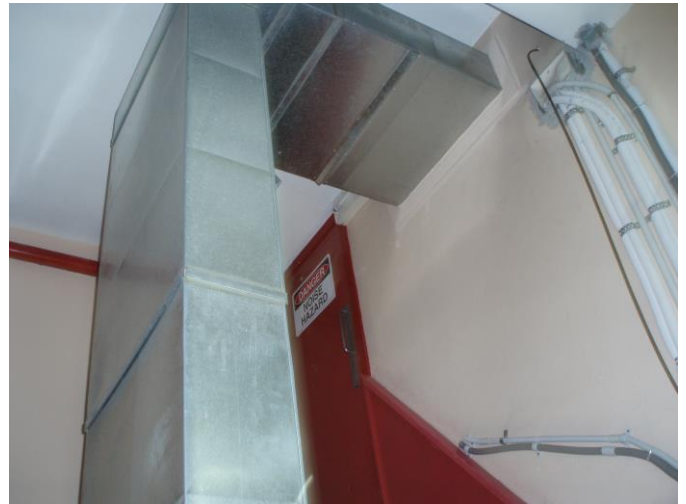
- The existing carpark ventilation system, does not currently comply with current code requirements
- The existing vertical riser infrastructure is limited within the existing building layout. The existing vertical stairwell in some instances on the upper levels, serves as a riser shaft for the passage of ductwork between floors, this is a potential fire engineering compliance issue.

Passage of ductwork through existing riser highlighting spatial riser issue

- The new proposed vertical riser infrastructure currently documented on the Architects drawings, mitigates issues with the current vertical riser limitations of the existing building. In terms of current sizing this would need further design review at later stages of design

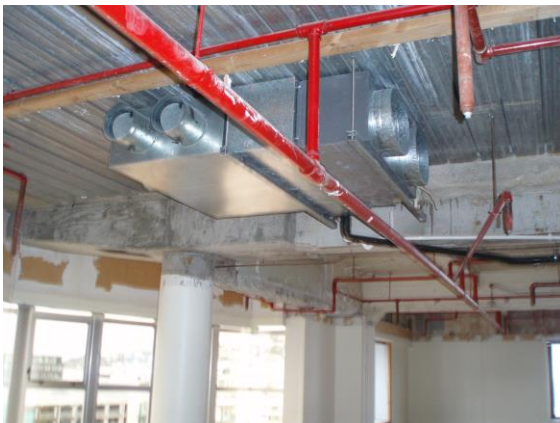
Typical Ceiling Void HVAC installation

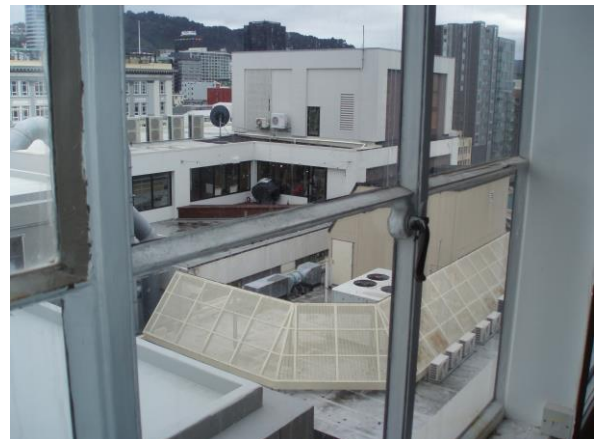
- During review of the upper levels of the building, existing chiller plant on the adjacent building at 97-99 Courtenay Place was observed. This noise is likely to cause hotel noise complaints, and requires further review.

Adjacent building boundary noise issue (Chiller)

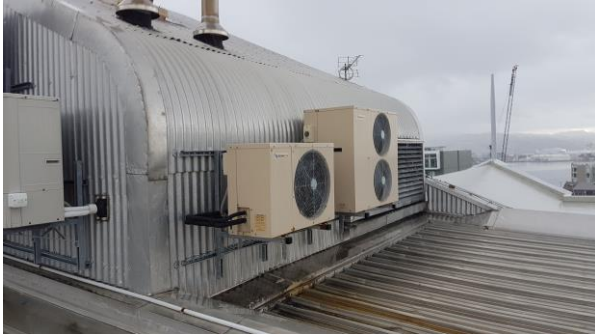
Existing Roof Plant

- A high level review of the existing plant room has been undertaken, indications are that some modification, possible extension or additional mezzanine floor (subject to structural review) is required for house central plant, which would consist of:

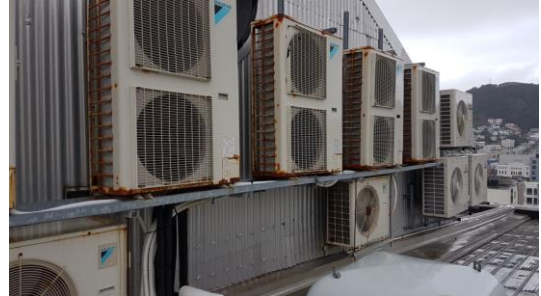
- The existing building heating/cooling plant (variable refrigerant flow (VRF) and split system conditioners) have been installed to suit tenancy requirements and are unsuitable for the proposed hotel development.

Existing HVAC Condensers

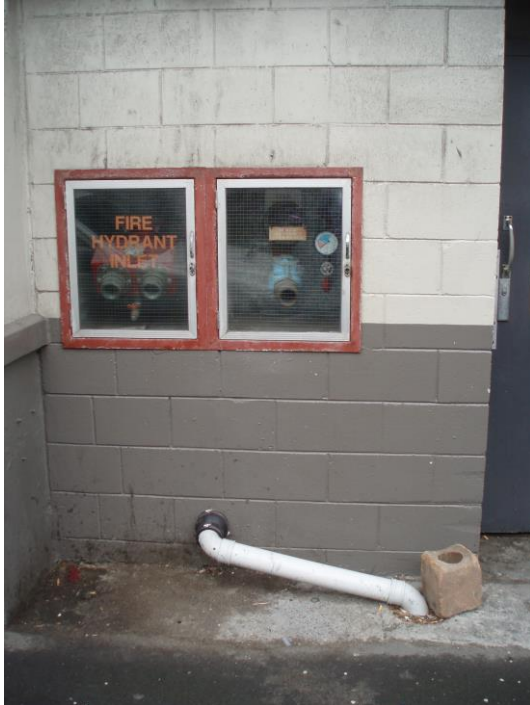
Existing Brigade Inlets

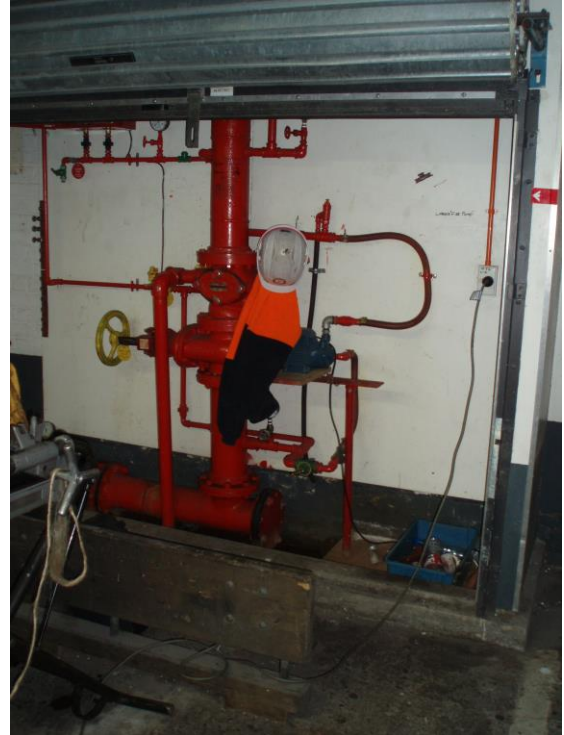
Existing Sprinkler Valveset

- The existing fire sprinkler coverage throughout the building will require to be upgrade to suit the new development
- The existing sprinkler valveset will require upgrade to a new enhanced safety valveset to comply with current NZS4541 requirements

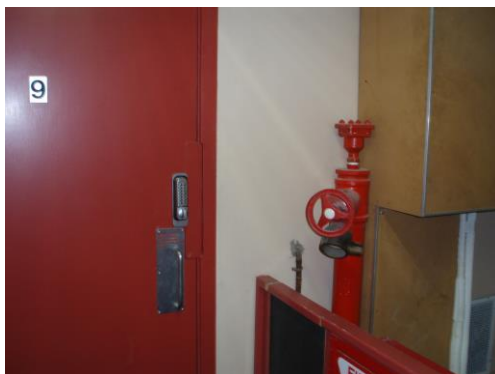
- The existing building appears to be provided with external drenchers located over the western façade windows for fire engineering design compliance
- The existing hydrant outlets set out within the stairwell risers, is unlikely to comply with current code requirements

Hydrant outlet spatial clearance issue

- The existing dry riser hydrant system will likely need to be converted to a charged riser (subject to HFS confirmation, and NZS4510 compliance review), and stairwell outlets modified to comply with NZS4510 requirements.

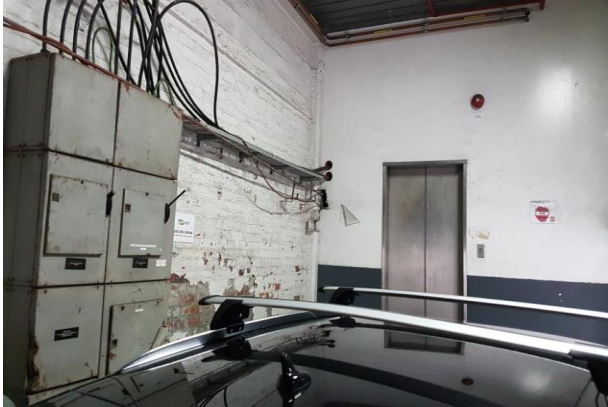
- Main switchboard is located at grid A.5 / 8 (Loading dock) and is no longer serviceable (available spare parts & age of equipment).
- Existing sub distribution board on Podium L1 located at grid D / 8 is new although the room location is likely to be problematical for the new Architectural layout.

Main Switchboard at Ground Floor Goods Lift

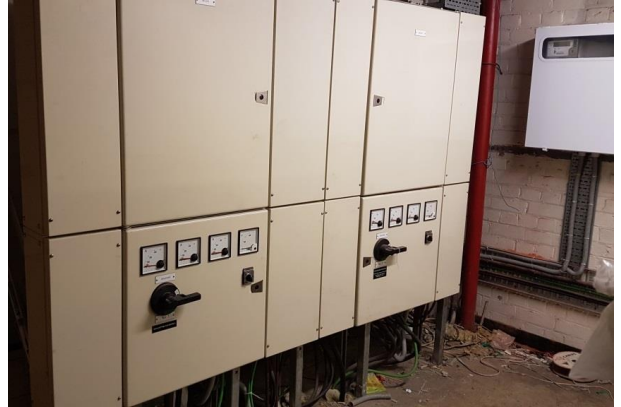
New Sub-Main Switchboard on Podium L2

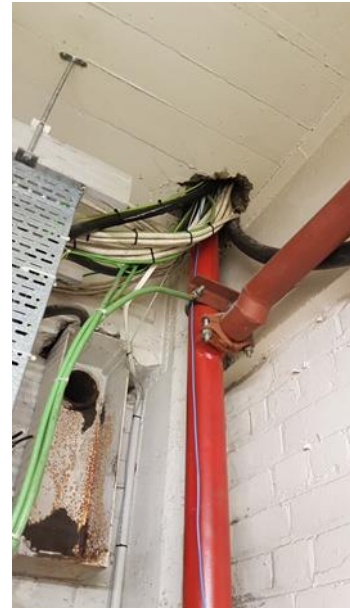
- Vertical rises for electrical cables were not vertically aligned on all floors of the building and were generally of inadequate size.
- Access was not possible to the existing ground floor switchboard cupboard, which is located on grid 6 between D and F. The cupboard doors are recently painted so possibly the switchboard has been upgraded.

Cable Riser to Upper Floors

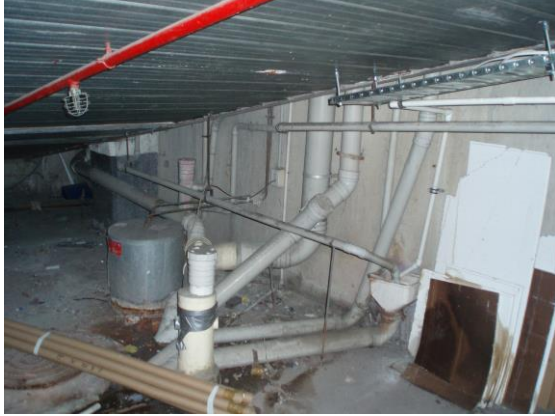
- Indications are that the size of the existing sanitary drainage connection to the WCC mains appears to be only a Ø150mm connection. For the proposed development a new single Ø225 connection is likely to be required to support the proposed hotel development.

Grd floor sanitary riser connection to manhole

- The size of the existing sanitary drainage connection to the WCC mains will require upgrade to a new single Ø225 connection to support the hotel development. Further review of the Wellington Council York Street sewage mains size is required to determine if a new Ø225 proposed new hotel connection is possible.

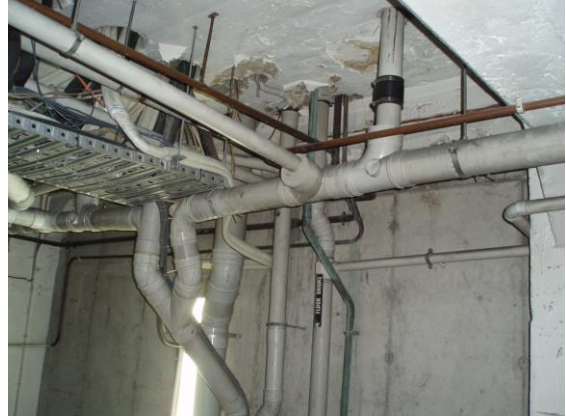
Drainage pipework within carpark
